Aquatic Facility Inspection Report

Date of Inspection: 10 October 2016

Location: East Pennsboro Middle School Natatorium

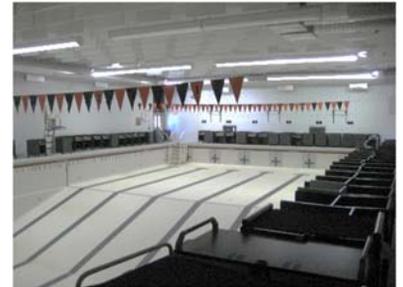
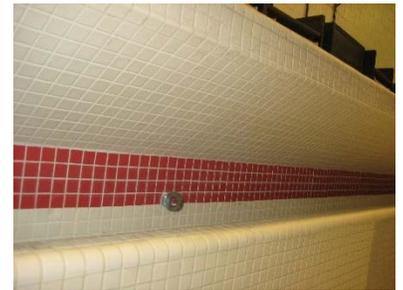
At the time the subject pool was designed, it was not appreciated that most contamination in the water, while invisible, is at the very surface, making an effective perimeter overflow system of key importance in the control of water-borne pathogens. While it is still in very good condition, the perimeter system on the subject pool is too small and has too few

outlets to be effective as it will easily flood with even moderate bather activity. Current codes and best design practices require static and dynamic surge storage equivalent to one gallon per square foot of water surface area. The present pool architecture and mechanical system accommodates virtually no surge storage which is why the pool gutter floods and becomes ineffective when operated as designed. The present pool/gutter architecture also presents a difficult freeboard dimension of 14" (distance between the water level and the deck level) making egress more cumbersome than necessary.

A new stainless steel integral perimeter system could take the place of all the existing gutter and gutter/filtered water supply perimeter piping as well as provide increased flow capability in the gutter channel, in-pool surge capacity and could be mounted higher to increase the water depth to 4'-0" at the shallow end, which is a better depth for competitive flip turns. Such a system, which resolves all of the pool architectural and perimeter process piping deficiencies for the remaining life of the building, would be a good investment. A review of the original structural drawings of the pool wall and deck interface must be conducted to determine if a new stainless steel system could be retrofitted.

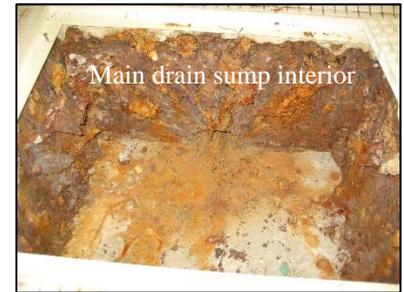
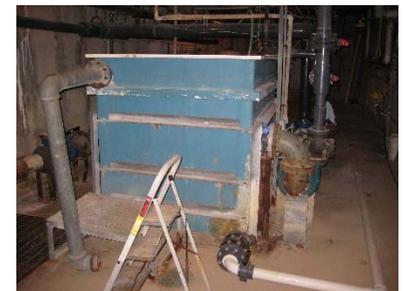
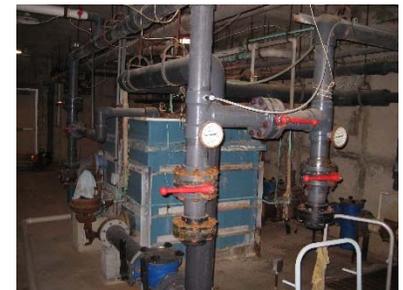
The existing main drain grates are compliant with current Federal anti-entrapment codes, however the drain sumps and embedded piping were constructed of ferrous metal and are very badly corroded. They are well passed their useful life expectancy and could fail at any time causing serious water loss and potential erosion of the pool structure subbase. District staff reports that the embedded pipes were recently inspected by camera and that the condition of the interior of the piping that carries the water to the filter system is similar to the interior of the drain sump.

The existing filtration system is a vacuum diatomaceous type consisting of an open, fiberglass tank that contains fourteen filter elements. It is serviced by a 7½ HP pump. The filter system has the capacity to filter all of the pool water once every eight hours. The current code requires a capacity to filter the water in six hours, making the system about 25% undersized. Staff reports filter tank leakage in one or two locations (could not be confirmed at time of inspection).

As one might imagine, an open tank located below water level could be prone to overflowing and flooding its environment. The mechanism that prevents this from happening is known to fail occasionally especially as it ages and flooding has happened once in the past two years, which was the limit of the historical memory of the two staff members accompanying us during our visit. We note the presence of three-phase, 240-volt electrical service in the filter area, making any flooding very dangerous. Much of the exposed bottom drain piping connecting the pool to the filter is the original ferrous metal which is heavily corroded. Some non-essential service valves incorporated into the metal piping have been essentially abandoned in place by staff not wanting to risk valve failure by operating them.

Cleaning the filter involves draining the water out after it's been isolated from the pool, and manually cleaning the dirty diatomaceous earth off of the filter elements with a garden hose. The residual slurry in the bottom of the tank is then drained by gravity into the sanitary line traveling under the filter room floor. Staff then allows pool water into the tank which is in turn drained as rinse water. Staff advises that essentially four tanks full of water are drained during the cleaning process, which we would estimate occurs every six weeks or so. We would estimate the waste water discharged during each cleaning sequence to be approximately 2,500 gallons. The chlorine in the waste water would dissipate over 7 – 10 days if it were stored before being discharged into the sanitary piping. There is adequate access and space in the filter area for appropriate storage tanks without modifying the existing piping or doorway and the waste water slurry from the filter could be pumped into storage tanks rather than drained by gravity. If the District chose to do nothing else other than the minimum required to accommodate the new sanitary authority requirements, it could add the waste water storage and slurry pump and operate as before albeit on "borrowed time" considering the condition of the main drain sumps and piping.

1. Replace the main drain sumps and piping to the filter system to avoid unplanned interruptions and potentially serious damage. New sumps and piping should be sized to accommodate a six-hour recirculation rate. **Highest priority.**

2. We recommend that a new regenerative media filter be installed to replace the existing filter. **High priority**, ancillary benefits of the new system include the following;
